CASE STUDY

EX SITU SOIL VAPOUR EXTRACTION
REMEDIATION OF THE FORMER
WADE ALLOPRENE WORKS,
NORTHWICH

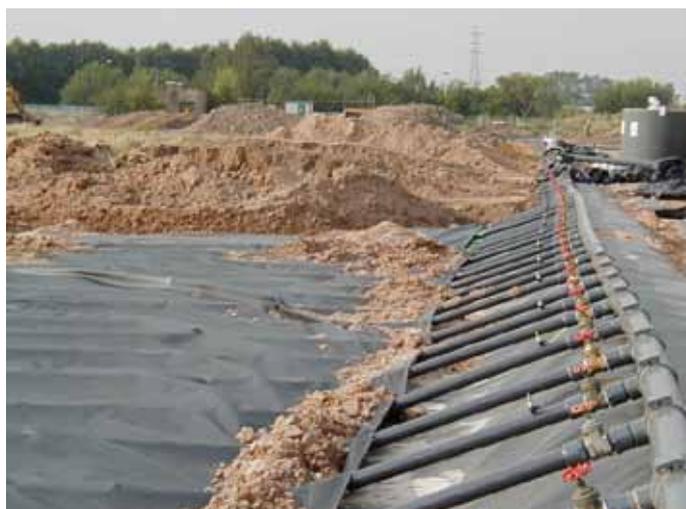
The pilot test revealed that a combination of contaminant distribution, soil properties and underground structures compromised the efficacy of an in situ SVE. RSK solved the problem by designing and constructing a large ex situ SVE system.

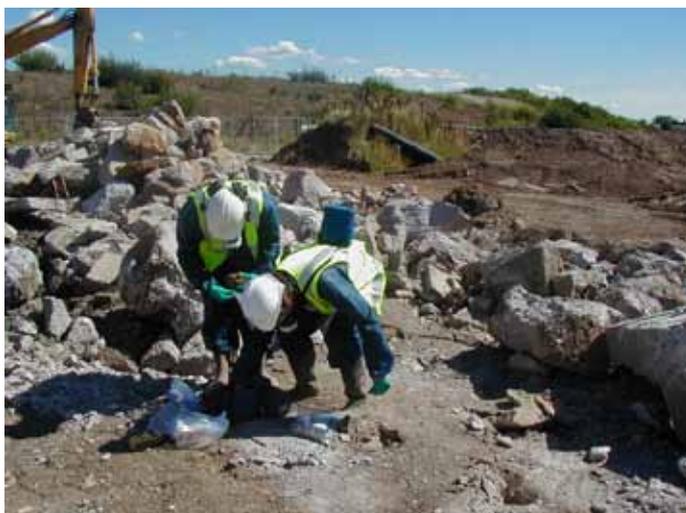
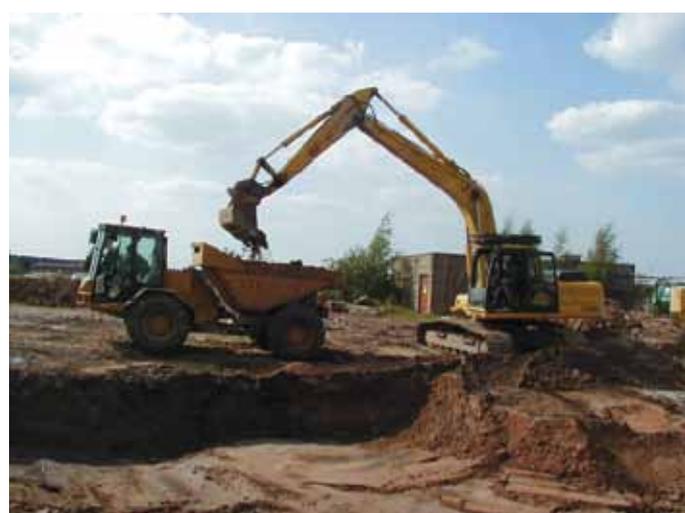
- a lined treatment bed with integral sump
- soil cover within the treatment bed
- maintenance of hydraulic control in the excavation during soil removal (water treatment requirement)
- SVE off-gas treatment by activated carbon adsorption
- extensive VOC monitoring (real-time photo-ionisation detector (PID), personal dose monitoring, boundary monitoring).

- Excavation area divided using a numbered grid
- Treatment bed divided into 23 numbered cells
- Excavation grid reference was recorded for soils placed in each cell
- Vapour concentrations noted at the 'face' during each grid square excavation
- Six headspace analyses using on-site PID conducted per cell for qualitative assessment of soil contaminant levels
